BROWNSVILLE

STRUCTURES

STUDY

July 2012

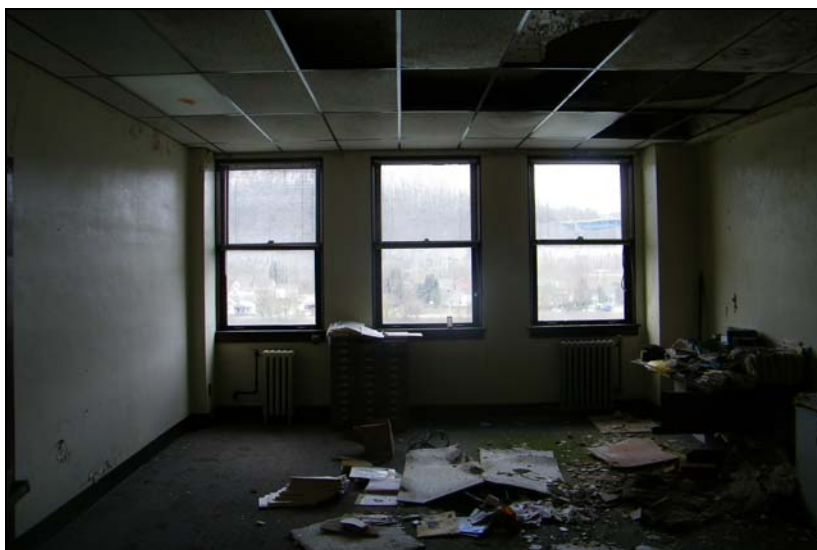
General Conditions: Building is solid and stable
Significant roof leaks have caused damage to plaster ceiling
and wall surfaces but have not cause structural damage

Typical Upper Floor with water damage.

Stabilization Recommendations:
Patch roof
Repair/replace downspouts
Assure that all window openings are protected while providing
natural ventilation

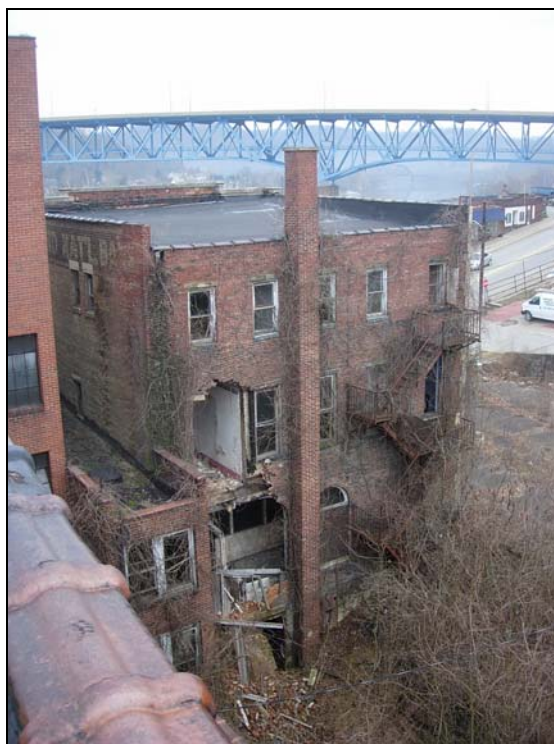
General Conditions: Extensive water damage to wood structural elements
Large section of rear wall collapsed

This small three story building includes a marble lined banking space on the main level and offices on each of the upper two floors reached by a stair leading directly up from Market Street. A significant section of the rear wall has collapsed on every level except the third floor and the section above will likely collapse in due time. Primary water damage is at the rear southeast corner of the building which is also the area of the exterior masonry wall failure.

Rear Elevation

Rebuild portion of rear brick wall that has collapsed

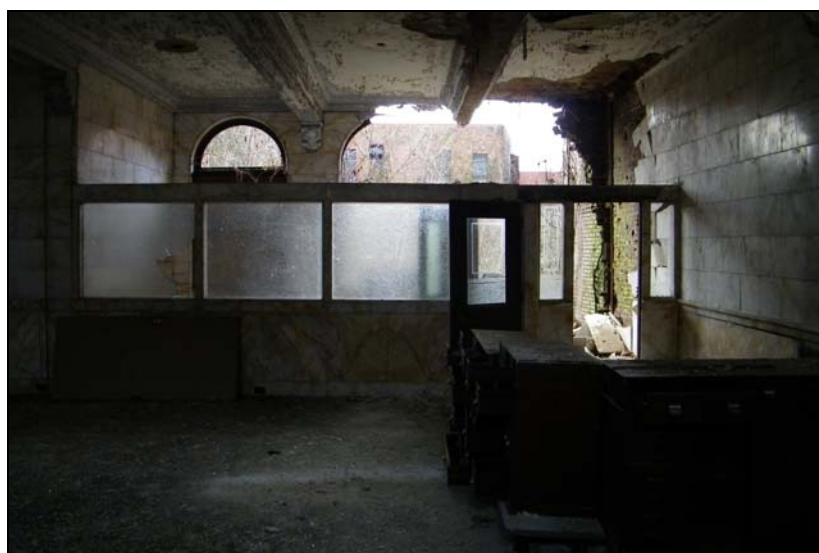
Main Floor looking to rear wall

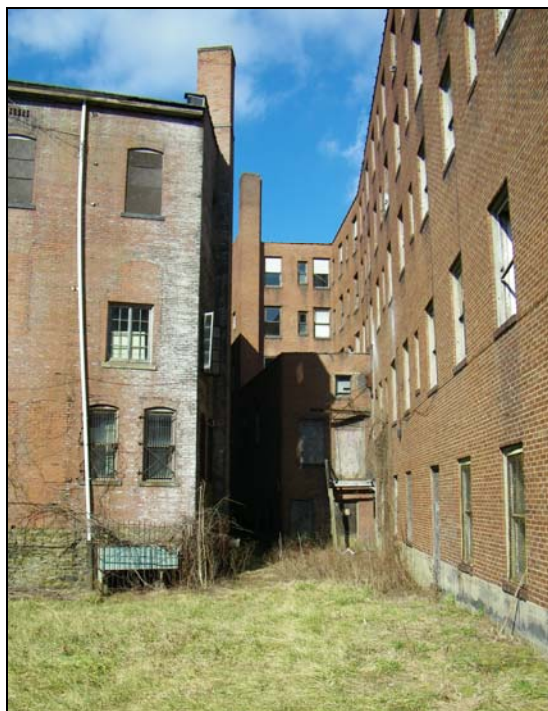
General Conditions: Roof leaks predominately at downspouts.
Fallen and loose plaster throughout the building
Severe water damage to structure at rear first floor rooms

Rear Elevation

Repair main roof
Replace lower roofs
Repair/replace downspouts
Assure that all window openings are protected while providing natural ventilation

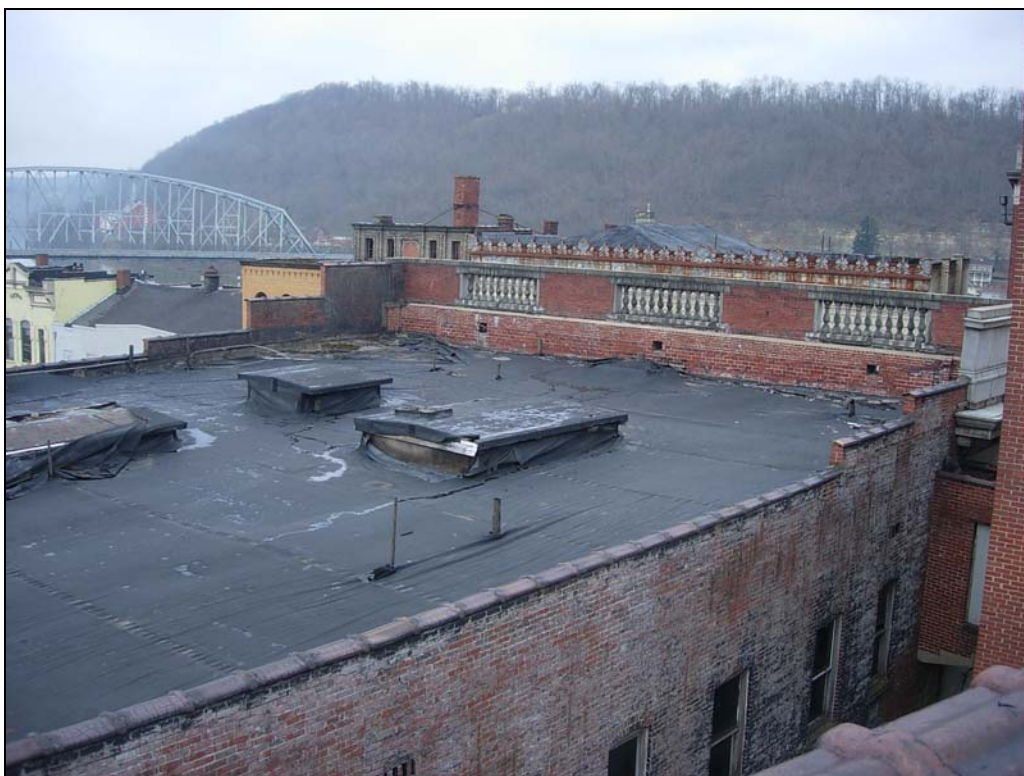
General Conditions: Extensive water damage at upper floors especially at front spaces
Decorative plaster ceiling in banking hall intact but stability unknown

Roof

Install new roof, downspouts

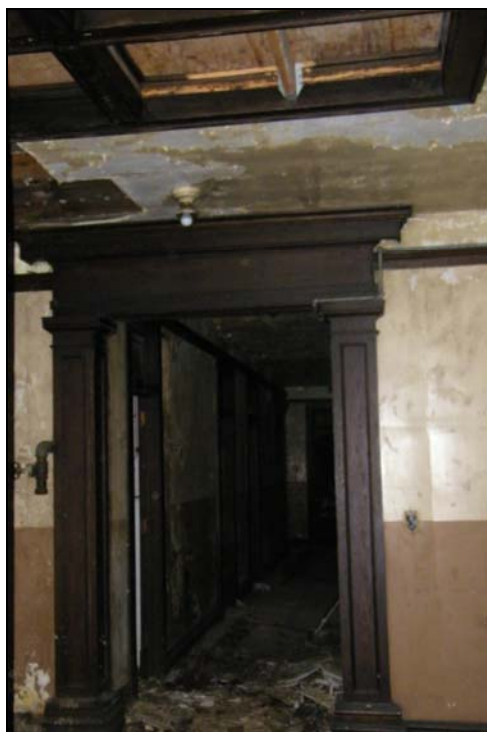
The Monongahela Bank Building is organized around the main banking floor which is a two story high space. The main entry on Market Street leads to a foyer which includes stairs to the second floor. The second floor is "L" shaped, wrapping around the West and South sides of the Main Banking Hall. Near the center of the south wall, a stair connects the second floor to the third floor which occupies the entire upper level. The third floor is divided into offices which have suffered extensive water damage. The water damage does not appear to have affected the structural integrity of the roof and floor systems, however, it will if stabilization measures are not implemented. The ornamental plaster ceiling of the Banking Hall does not show signs of failure but its condition will continue to deteriorate until the water infiltration from the third floor is stopped.

Third Floor Offices

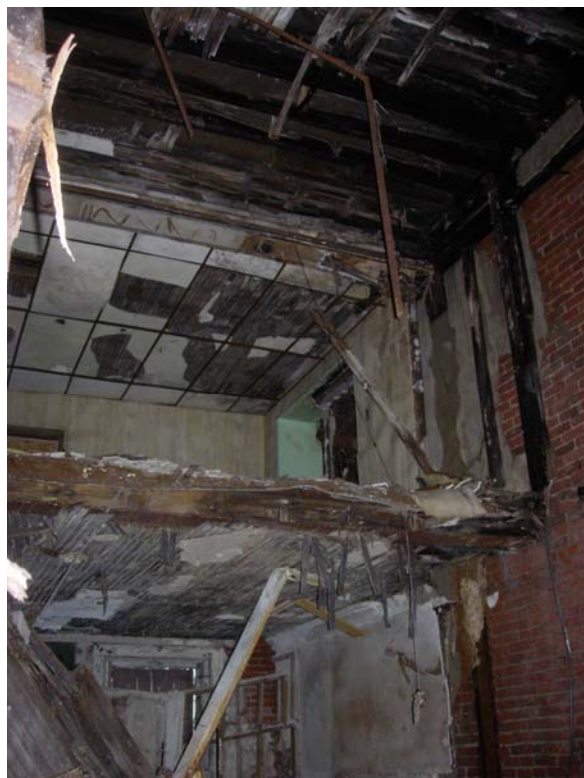
The front of this structure follows the curve where Water Street diverges from Market Street. On the first floor a large intact recessed storefront exists at the two southernmost bays and a single modified storefront stands at the northernmost bay. Between these a narrow bay contains the entrance to what appears to have been a large east west stair hall which provided access to the upper floors. The stair and large sections of the first, second and third floors have collapsed in this area. The two retail bays to the south of the entry corridor are in a severely deteriorated state. Portions of the second floor have collapsed in both spaces. The first floor is not structurally sound in large areas.

First Floor South Bays

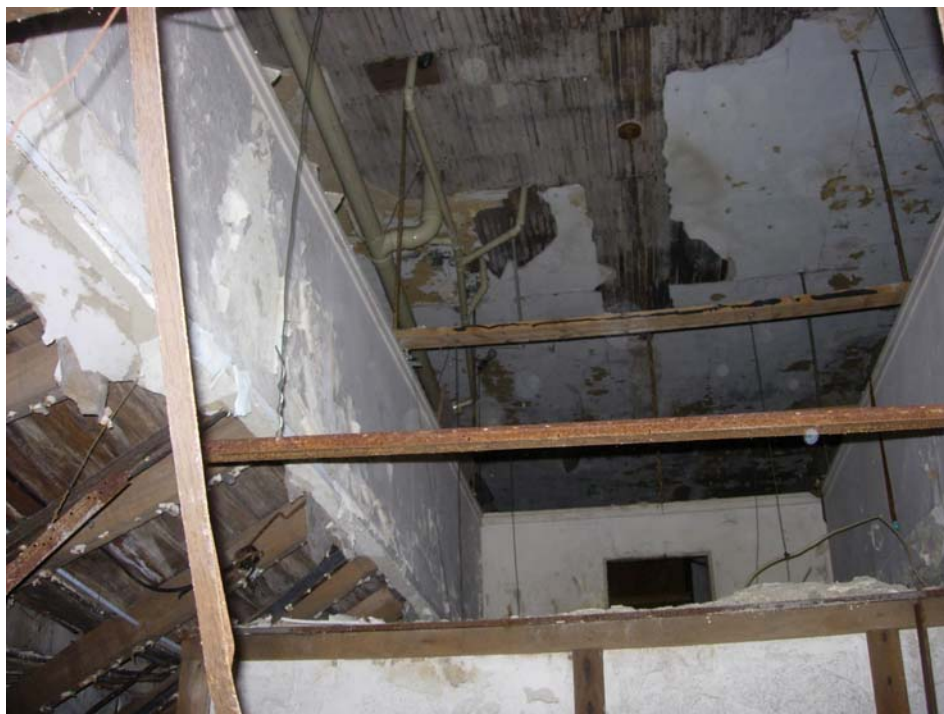
The retail space to the north of the entry corridor is in the best condition. There is moderate water damage and portion of the first floor is unstable. A four sided balcony is visible above the modern dropped ceiling.

First Floor North Bay

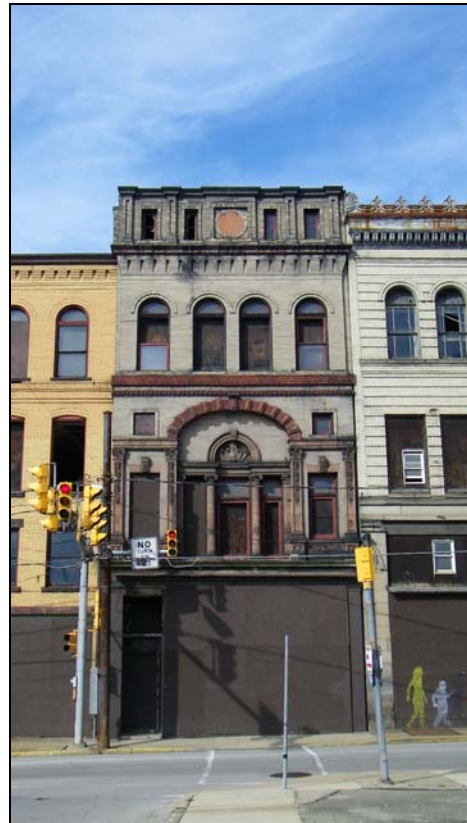
41 Market Street

41 Market Street, has collapsed from the roof. A portion of the structure remains at the Market Street façade and at the westernmost bay. There is no sign that the structural integrity of the party walls and the front and rear facades is compromised. There are no signs of bulging or cracking in these facades.

Install new roof structure where existing has collapsed

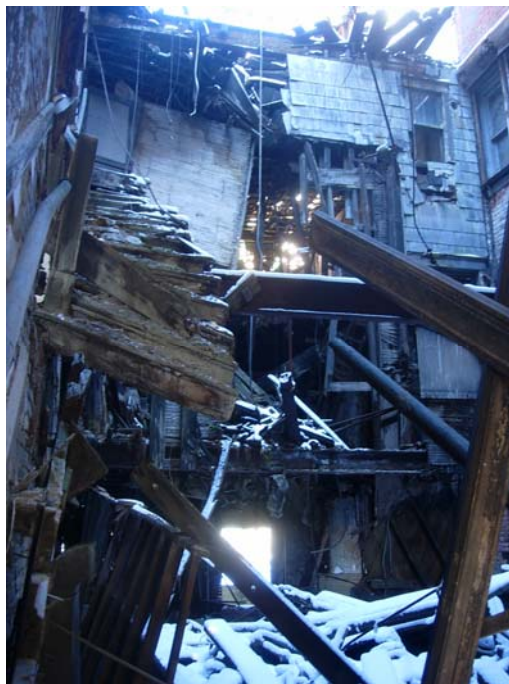
Interior of 41 Market Street

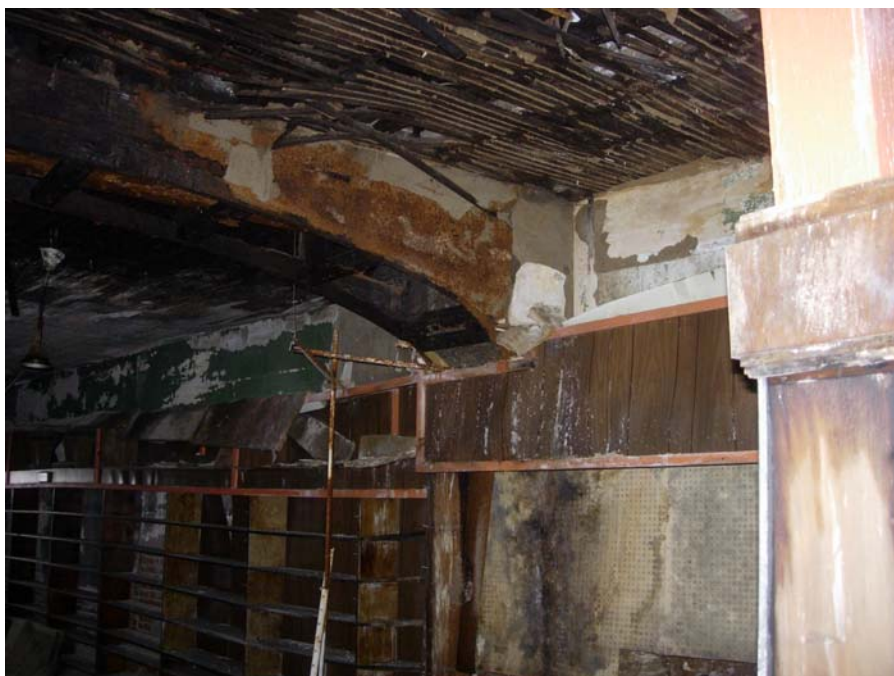
The southern structure in this pair (39) is a four story yellow brick building. The recessed storefront area in fair condition. The first floor is in an advanced state of decay with deteriorated first and second floor structures.

First Floor of 39 Market Street

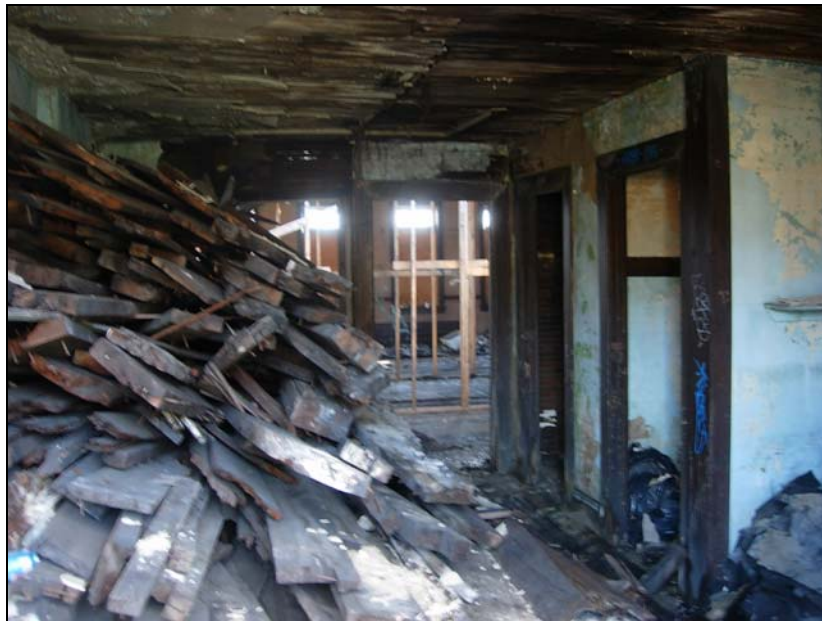
What was originally likely a storefront has been severely altered at the first floor Market Street elevation of this three story white brick building. The interior is devoid of original architectural details on the first floor and significantly water damaged throughout. Partial demolition of interior partitions is visible at the third floor.

Third Floor

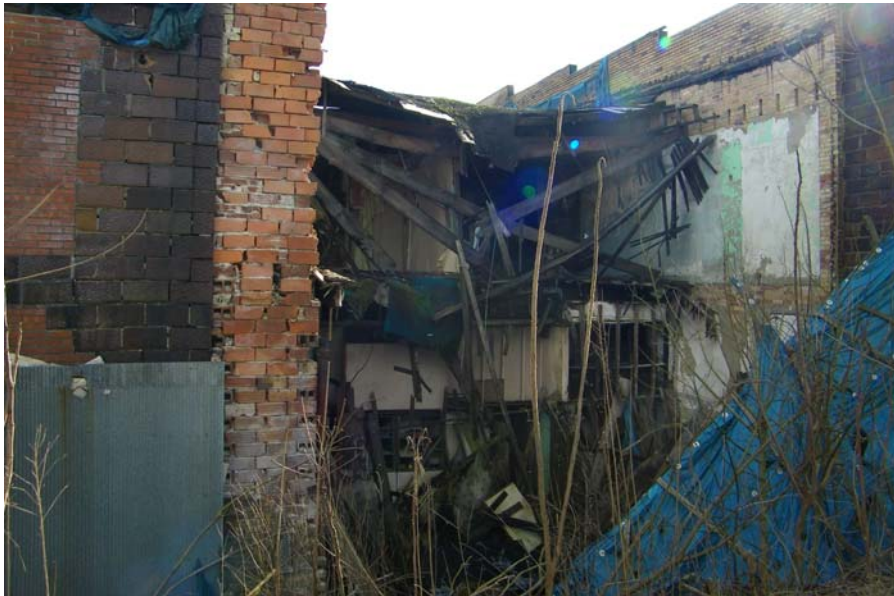
General Conditions: Rear of structure has collapsed

River Elevation

Seal rear of building at last structurally sound bay

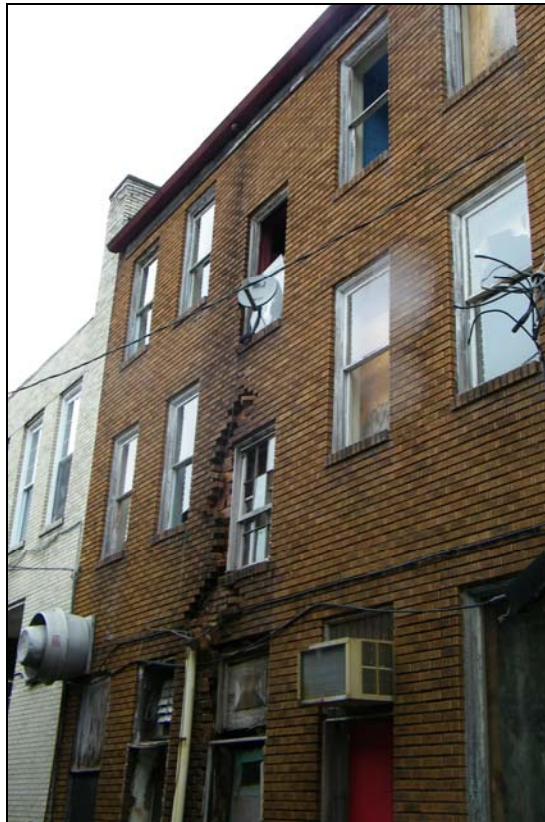
General Conditions: The second and third floors were inaccessible
The rear wall is severely shifted and cracked

This is a three story brick building with a bar/lounge on the first floor. The second and third floors were inaccessible but are assumed to contain meeting rooms. The brick at the rear wall is heavily cracked and shifted out of plumb.

Rear Elevation

Patch roof
Remove loose debris
Stabilize rear wall
Assure that all window openings are protected while providing natural ventilation
