BROWNSVILLE

STRUCTURES

STUDY

July 2012

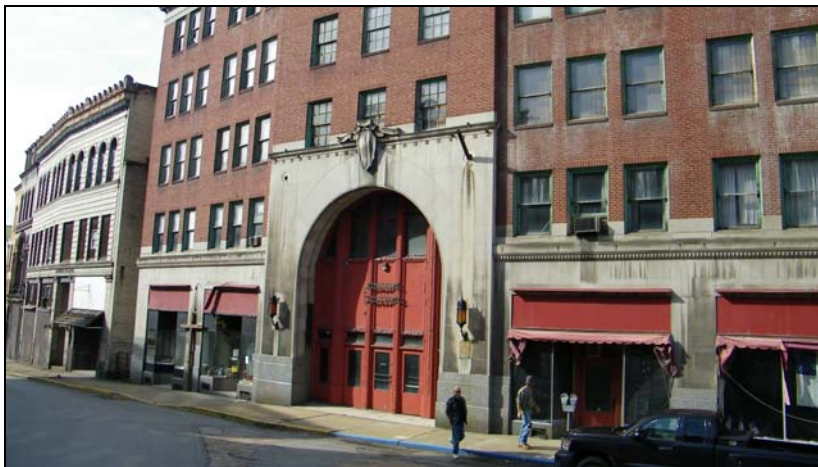
Market Street Elevation

General Conditions: Building is solid and stable
Significant roof leaks have caused damage to plaster ceiling
and wall surfaces but have not cause structural damage

The train station building is the most heavily structured building within the scope of this study and has suffered the least damage due to water infiltration. The building is entirely of non combustible construction composed of concrete encased steel (possible reinforced concrete) with construction tile and concrete floors. Interior partitions are plaster on construction tile.

Stabilization Recommendations:
Patch roof
Repair/replace downspouts
Assure that all window openings are protected while providing
natural ventilation

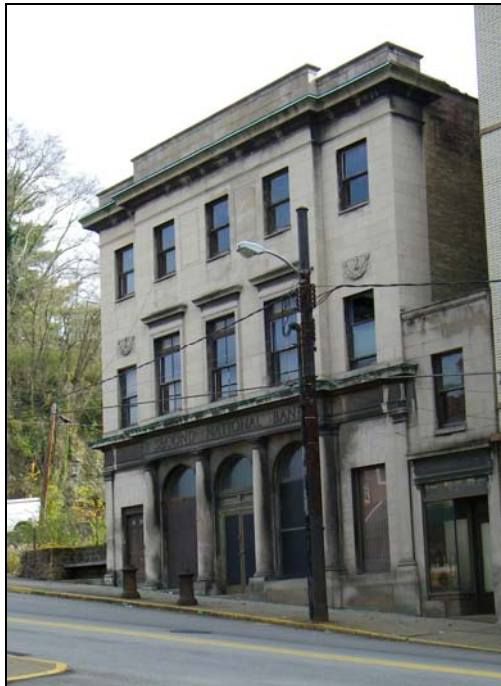
Market Street Elevation

General Conditions: Extensive water damage to wood structural elements
Large section of rear wall collapsed

This small three story building includes a marble lined banking space on the main level and offices on each of the upper two floors reached by a stair leading directly up from Market Street. A significant section of the rear wall has collapsed on every level except the third floor and the section above will likely collapse in due time. Primary water damage is at the rear southeast corner of the building which is also the area of the exterior masonry wall failure.

Replace downspouts

Assure that all window openings are protected while providing natural ventilation

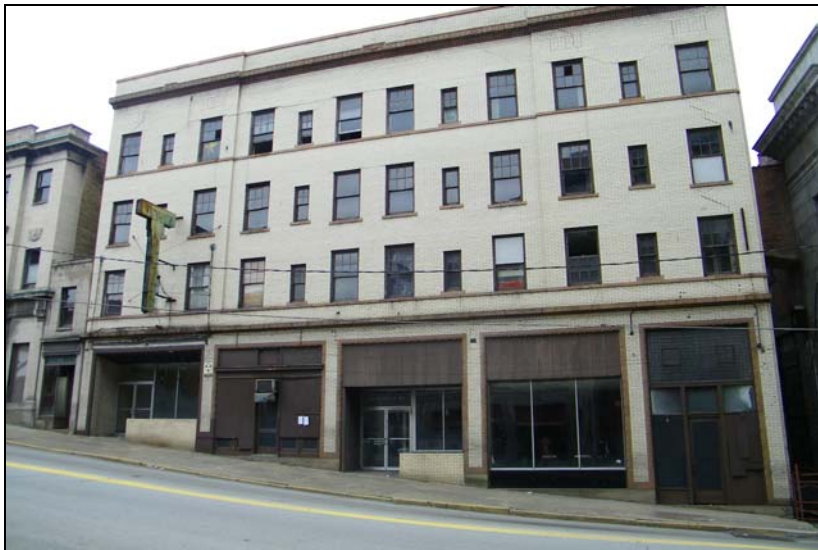
Market Street Elevation

General Conditions: Roof leaks predominately at downspouts.
Fallen and loose plaster throughout the building
Severe water damage to structure at rear first floor rooms

The main roof is in poor condition but major roof leaks are limited to downspout areas. The lower roofs which cover first floor spaces that extend beyond the line of the upper floors are in poor condition.

Repair main roof
Replace lower roofs
Repair/replace downspouts
Assure that all window openings are protected while providing natural ventilation

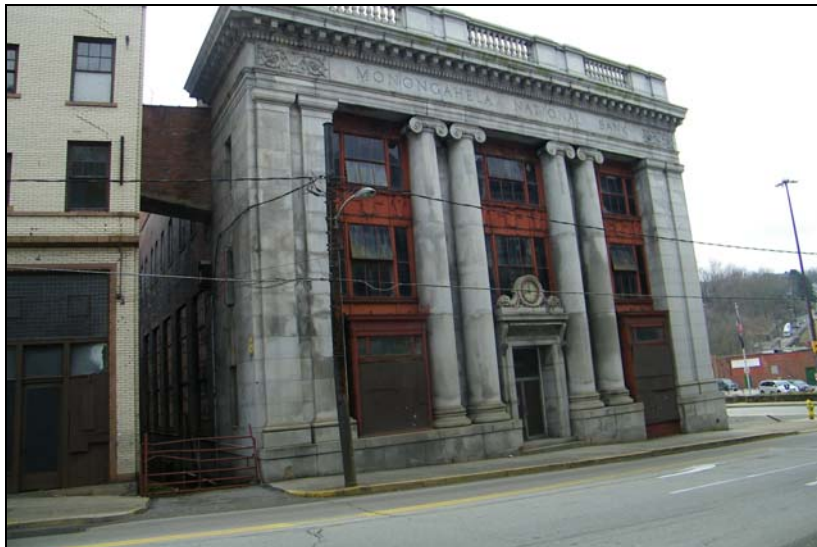
Market Street Elevation

General Conditions: Extensive water damage at upper floors especially at front spaces
Decorative plaster ceiling in banking hall intact but stability unknown

The Monongahela Bank Building is organized around the main banking floor which is a two story high space. The main entry on Market Street leads to a foyer which includes stairs to the second floor. The second floor is "L" shaped, wrapping around the West and South sides of the Main Banking Hall. Near the center of the south wall, a stair connects the second floor to the third floor which occupies the entire upper level. The third floor is divided into offices which have suffered extensive water damage. The water damage does not appear to have affected the structural integrity of the roof and floor systems, however, it will if stabilization measures are not implemented. The ornamental plaster ceiling of the Banking Hall does not show signs of failure but its condition will continue to deteriorate until the water infiltration from the third floor is stopped.

Remove all loose and water saturated materials

Assure that all window openings are protected while providing natural ventilation

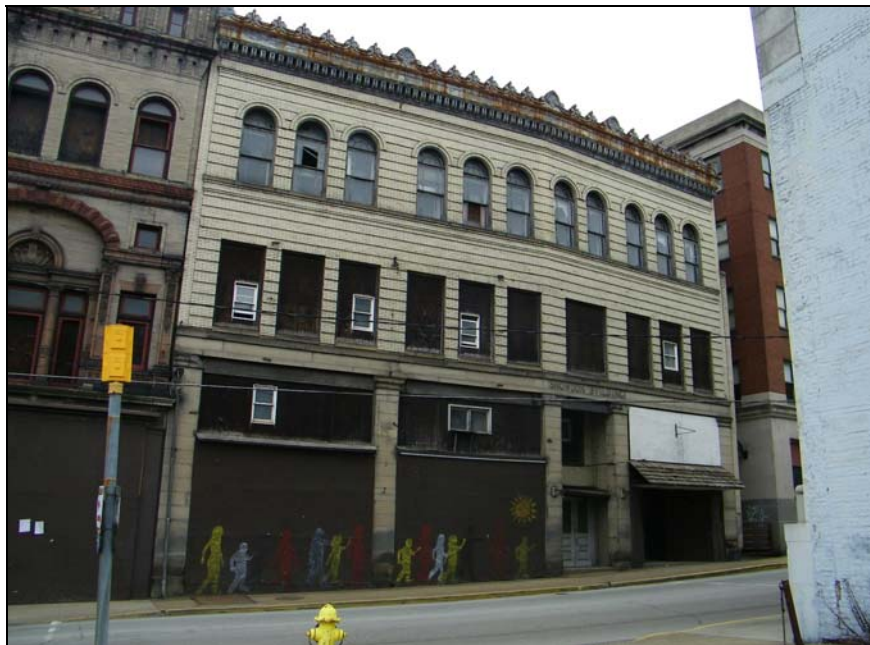
Market Street Elevation

General Conditions: Upper floors are inaccessible
Center stair hall has collapsed
Southern two bays in advanced state of deterioration

The front and rear walls of the structure appeared to be structurally stable with no signs of bulges or cracks.

Install new roof structure where existing has collapsed
Install new roof and downspouts
Remove all loose and water laden materials
Assure that all window openings are protected while providing natural ventilation

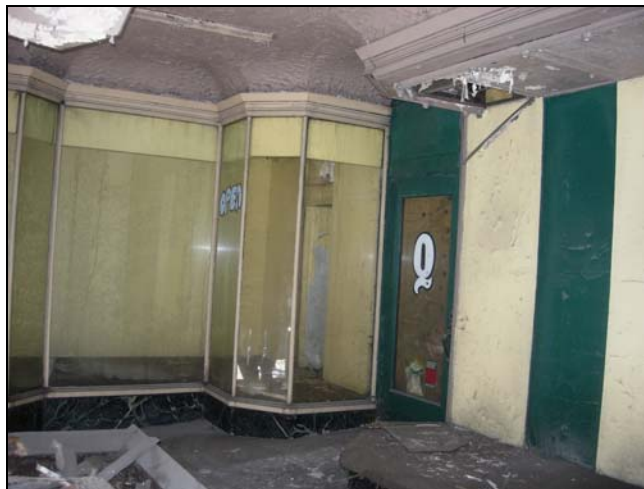
Market Street Storefront Area – South Bays

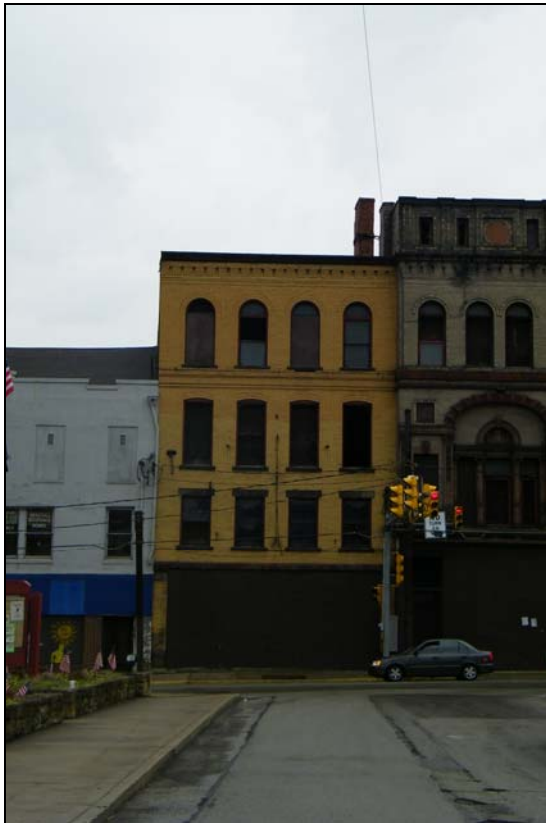
39 Market Street

General Conditions: The roof and upper floors at 41 Market Street have collapsed from the roof to the basement. A portion of the floors in poor condition remains at the front and rear of the building. The interior of 39 Market is in an advanced state of decay.

The southern structure in this pair (39) is a four story yellow brick building. The recessed storefront area in fair condition. The first floor is in an advanced state of decay with deteriorated first and second floor structures.

Remove all loose and water laden materials

Assure that all window openings are protected while providing natural ventilation

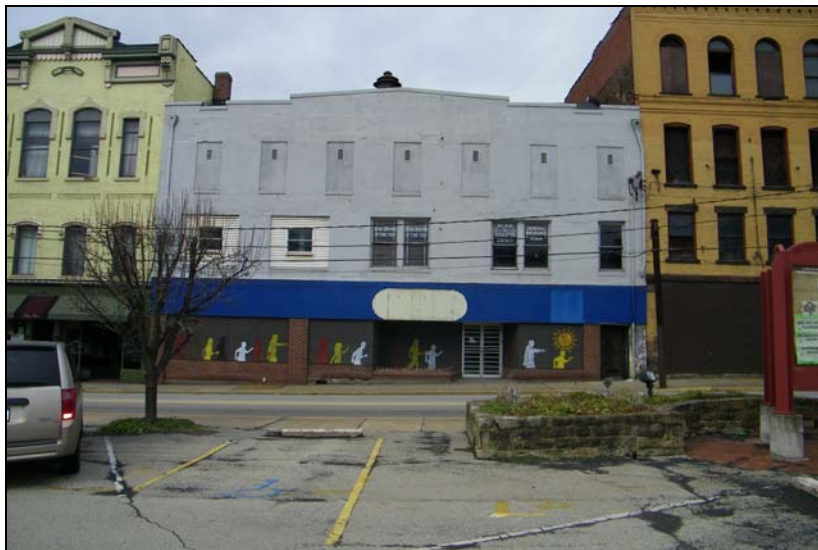
Market Street Elevation

General Conditions: No obvious water damage
Modern interior finishes on first floor
Upper floors inaccessible

Clean out loose debris
Provide ventilation at windows
Assure that all window openings are protected while providing natural ventilation

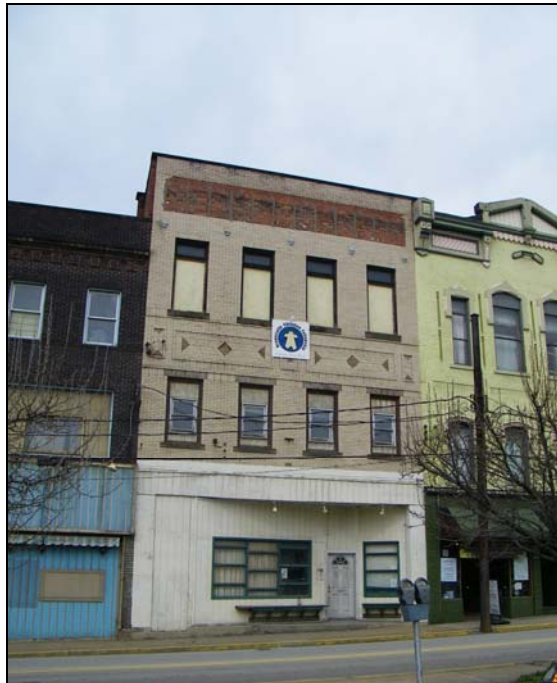
Market Street Elevation

General Conditions: Extensive water damage throughout space
Stair to third floor in very poor condition

What was originally likely a storefront has been severely altered at the first floor Market Street elevation of this three story white brick building. The interior is devoid of original architectural details on the first floor and significantly water damaged throughout. Partial demolition of interior partitions is visible at the third floor.

Stabilization Recommendations:
Repair/replace roof
Remove all loose and water laden materials
Assure that all window openings are protected while providing natural ventilation

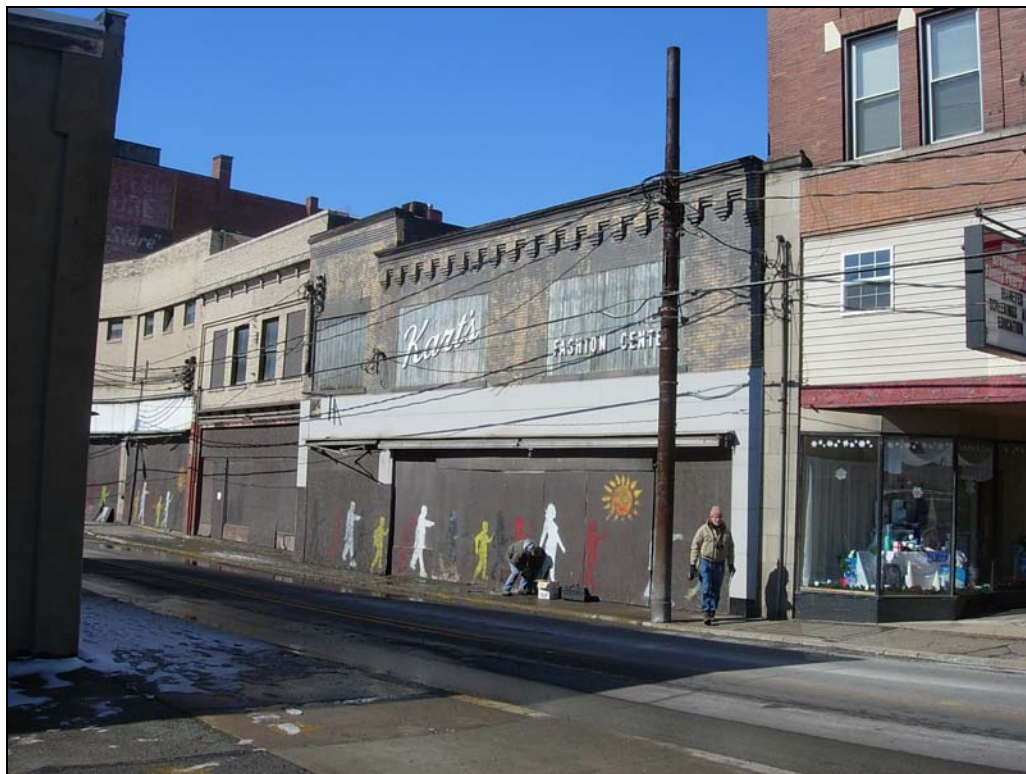
Market Street Elevation

Kart's is a two story brick building with storefronts lining Market Street on the first floor. The storefront area is accessible and in fair condition. The first floor area which is visible through the storefront windows appears dry with a central stair leading to the second floor. The rear of the building has a two story metal faced section which appears to be an addition to the original rear wall of glazed concrete block. An interior bearing wall is assumed to exit between the slightly taller southern portion of the building and the larger northern section.

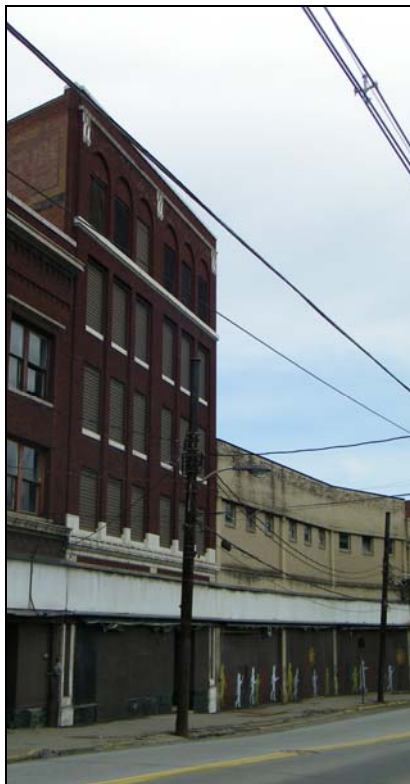
Market Street elevation of both structures

This property includes two buildings which were joined to provide retail and office space for the G. C. Murphy Company. The southernmost building is a five story brick structure with retail space contiguous to the adjoining building to the north on the first and second floors. The upper floors of this building were not accessible due to the collapse of the stair at the southwest corner of the building. The observable structure was in fair condition except for the water damage and stair collapse at the southwest corner. It is presumed that the upper floors are in similar condition.

The northern structure of this group is a two story white brick building with open retail space on both floors and glass storefronts lining Market Street on the first floor. Water damage is limited to the rear (west) wall where roof leaks and defective downspouts exist. Both structures are of brick bearing wall and steel frame construction. The floor structures are likely wood but may be constructed using bar joists in the two story building.

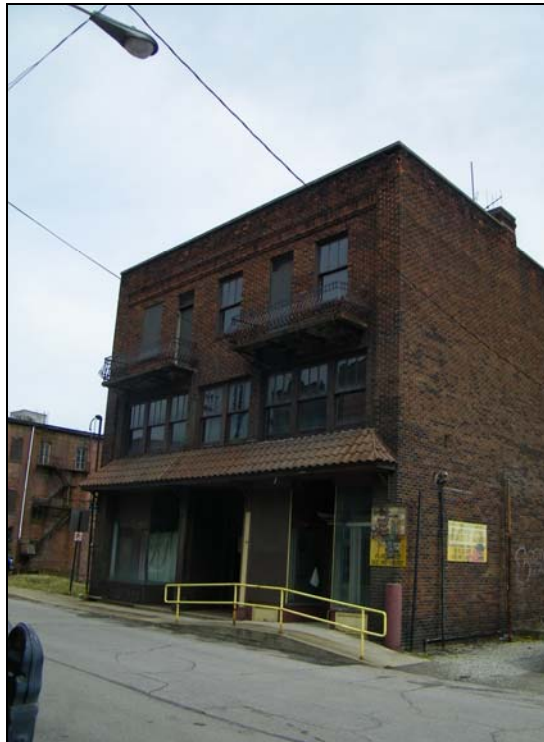
Brownsville Avenue Elevation

This modestly scaled three story building is in relatively good condition with roof leaks confined to isolated areas. A central stair leading to the upper floors divides the two retail spaces on the first floor. Two apartments occupy the second floor and a single apartment occupies the third floor.

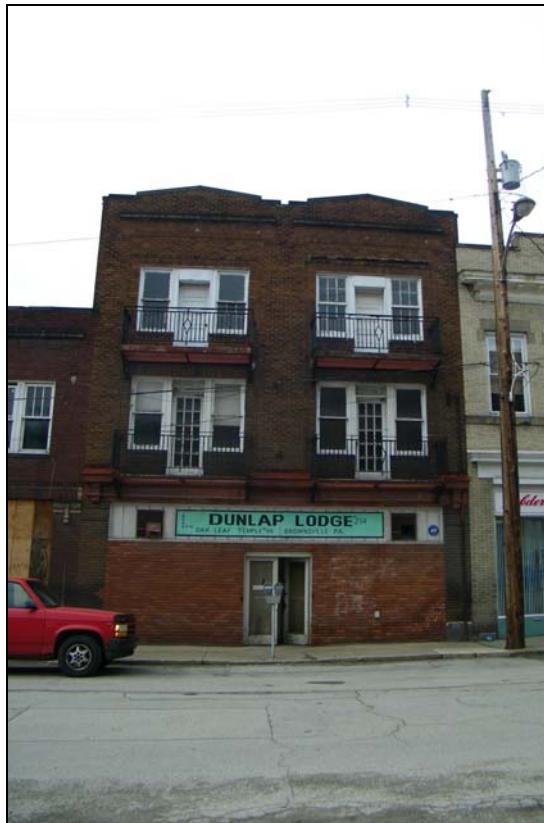
Lodge Front

General Conditions: The second and third floors were inaccessible
The rear wall is severely shifted and cracked

This is a three story brick building with a bar/lounge on the first floor. The second and third floors were inaccessible but are assumed to contain meeting rooms. The brick at the rear wall is heavily cracked and shifted out of plumb.

Patch roof
Remove loose debris
Stabilize rear wall
Assure that all window openings are protected while providing natural ventilation
